REF: **Soil Gas Sampling Report**
0311955090-Cook County-North Suburban Cleaners
7620 Dempster Street
Morton Grove, Illinois

Hydrodynamics Consultants, Inc. completed the soil gas sampling on July 22, 2014 in accordance with our soil gas sampling plan for North Suburban Cleaners. This letter summarizes the soil gas sampling results.

Site Base Map
LPC#:0311955090/Cook County
Morton Grove/North Suburban Cleaners
Site Remediation Program

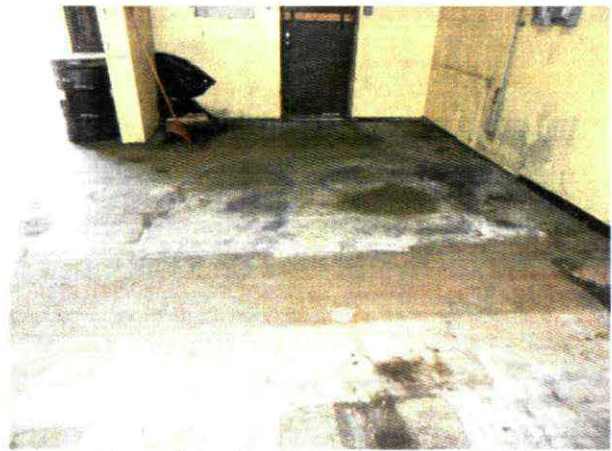
Former Drycleaning Machine Area (to the North)

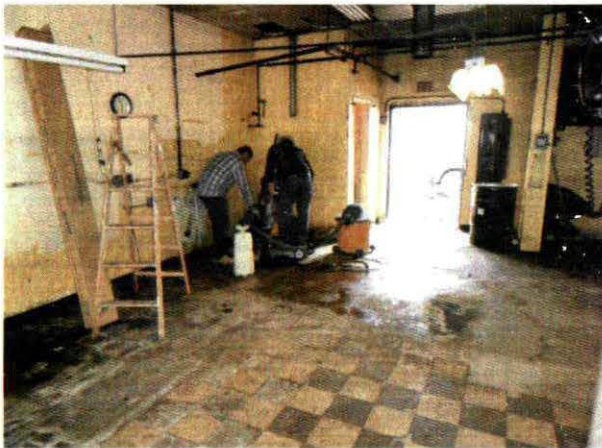
- SV6:** It is added in the area in the front of the restroom inside the building to determine if the neighboring stores could be affected by the soil vapor intrusion.

Coring Concrete Floor at SV6 Location

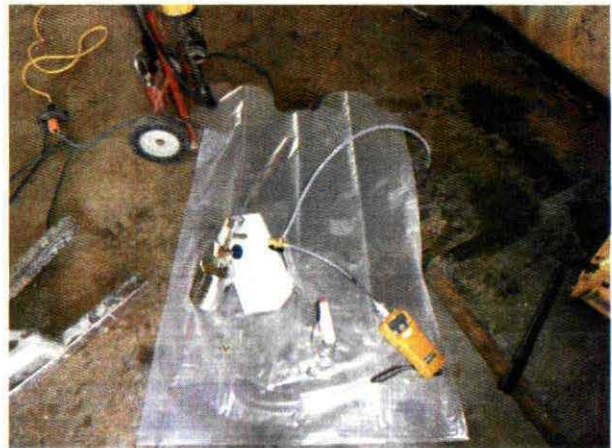
Soil Gas Sampling for SV6
